Landslides associated with the Kope Formation

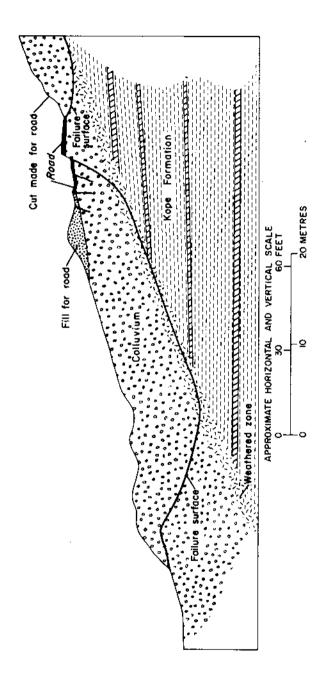
Figure 4.--Sketch of typical deep-seated landslide in colluvial material on the Kope Formation.

Two different modes of failure occur in the colluvial materials overlying the Kope Formation. In the first mode large landslides involving areally several thousand square feet of failed materials, such as those that have occurred along the Ohio River in Bromley, Kentucky, and Hillside Avenue and East Miami River Road in Hamilton County, Ohio, have the morphology of a typical slump (fig. 4). The crown area is characterized by open, crescent-shaped cracks, and the foot area by a series of transverse ridges which are suggestive of earthflow. The principal failure surface appears to have a composite geometry that is nearly vertical in the crown area, parallel to the bedrock surface in the interior of the slide, and curved, concave-upward in the foot area. Much of the length of the failure is along the gradational contact between the colluvium and weathered bedrock. A slide of this type is first indicated by one or more crescent-shaped cracks that develop in the upper part of the slope. A slope can exist in this state for several years. A fully developed failure surface is indicated by downward slumping in the area of the cracks, accompanied by bulging in the lower part of the slope. Movement tends to be slow, usually only a few feet per year, and there appears to be scant change in the morphology of the slope failure after it has become fully developed. The characteristic transverse ridges and bulges in the foot area that are suggestive of earthflow do not typically mobilize into flows. Small slumps commonly form in the main scarp of the landslide after it has become fully developed.

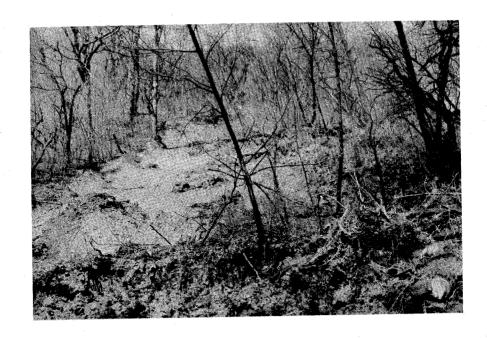
Figure 5.--Earthflow on Columbia Parkway, spring 1975. The semicircular channel on the left is part of the exposed failure surface.

Figure 5 illustrates a rapid earthflow that occurred in 1975 along Columbia Parkway. The earthflow moved over the retaining wall into the street, exposing layers of weathered bedrock below the surface of rupture.
